# Slating & Tiling TIPS 24

## Fibre cement slates: verge and side abutment fixing

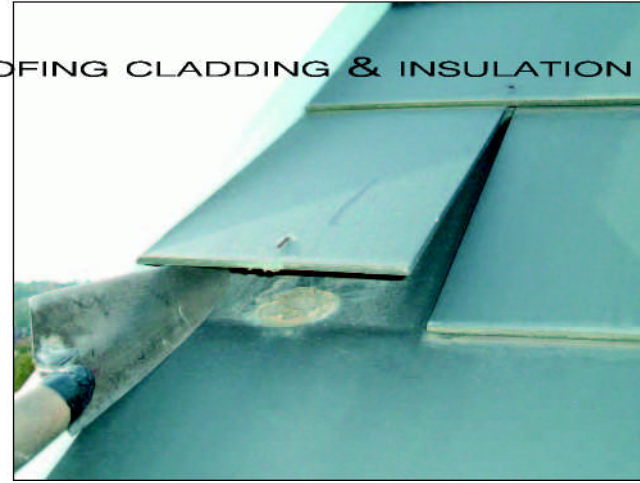
- The use of a half slate at a verge is normally very unstable as it is difficult to get two good centre nail fixings. In this instance, mastic used to hold the slate down failed within 12 months and the copper disc rivet was only fixed to the half slate and not to the slate below.

Once a verge or side abutment has been constructed, there are a few repair solutions. If the majority of the slates are not adequately fixed, the total verge or side abutment should be stripped back and started again. If there are only one or two isolated slates affected, it is possible to determine the centre line of the batten close to the rivet hole and

to drill through the two layers of slate at that point. Into the hole should be pumped some clear silicone mastic, before a stainless steel dome headed wood screw is installed. This method is only acceptable where the supervising officer allows the use of silicone mastic.

Under no circumstances should mastic be used between the slates to hold them down. After as little as one year the mastic can fail and then the problem will still need to be resolved.
