Slating & Tiling

TIPS 63

interlocking concrete tiles – broken corners

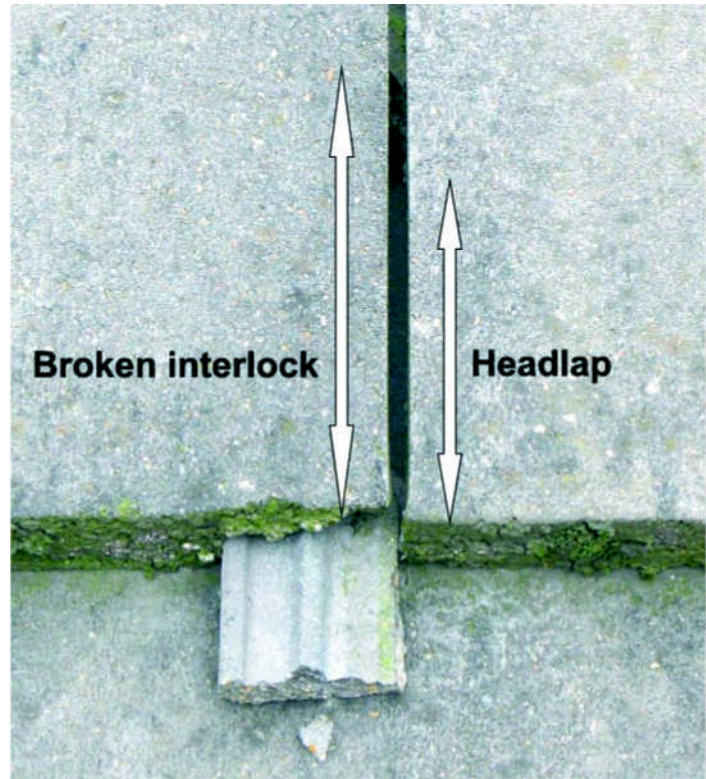
The sixth cause is how the tiles are laid. The tile design allows them to be pushed together or pulled apart by a few mm per tile to keep the tile courses straight. If the tiles are pulled out too far, the ribs in the interlock ride up on each other and lift the tile on the right hand edge, taking a large amount of the load

placed on the tile. This load can break the interlock, especially if the tiles are lifted by wind uplift or are walked on by the tiler.

Breakage of the right-hand lower corner is very obvious, while in the left-hand lower corner it is less obvious, as it leaves a rectangular hole. The breakage of the two top corners is only identifiable by dismantling the roof, so is therefore more serious.

- Profiled concrete interlocking tiles laid straight-bond tend to have stronger side interlock designs.
- Pack up the battens to eliminate any deviations in the level of the rafters, and fit all valley support boards between the rafters.
- Install the tiles using the correct fixing specification, obtained from the tile manufacturer.
