# Slating & Tiling

## TIPS 55

### timber battens – repairs

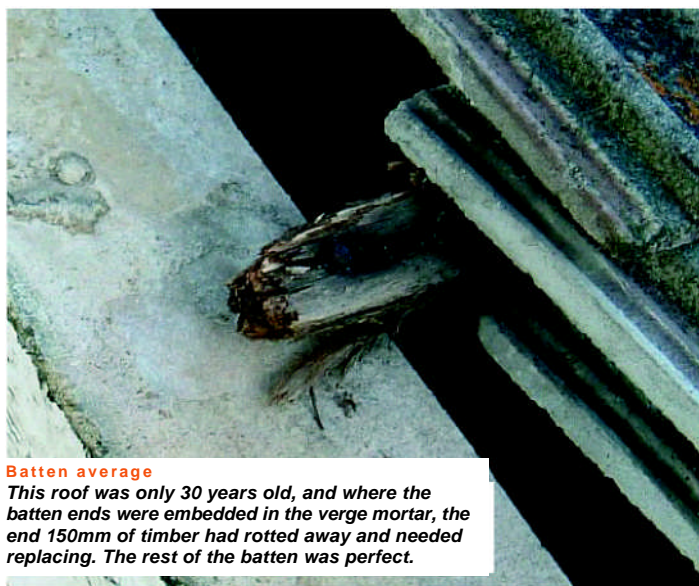
#### Batten average

*This roof was only 30 years old, and where the batten ends were embedded in the verge mortar, the end 150mm of timber had rotted away and needed replacing. The rest of the batten was perfect.*

Where the battens end at a verge or side abutment, and are either rotten because they have been embedded in the verge mortar, or need to be lengthened to allow for the correct installation of a dry verge system or gable wall cladding, the rotten or affected battens should be cut back and staggered, to make sure only one in any group of four consecutive battens join on one rafter. This means that the shortest batten will be about 1.5m long and the longest approximately 3.3m long where the rafters are at 600mm centres.

(and approximately 1.5m long) directly below the replaced end section of batten, and twice nail the short end section to the additional batten, then also nail the additional batten to each rafter and the existing batten for maximum rigidity.
