Slating & Tiling

TIPS 64

chimney & dormer units part 1

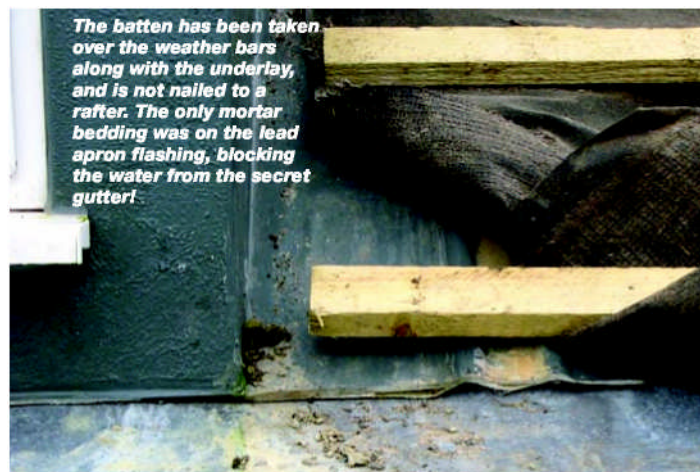
The flashing should either lap under the chimney/dormer window unit by a minimum of 150mm, or, if the distance is less, turn up to form a 50mm high vertical step within the unit construction. Where the apron flashing extends under the side flashing it is not possible to form a 50mm upstand, so the alternative has to be used. At this point the apron flashing will be unsupported, so a timber support board should be installed between the main rafter and the additional rafter, and to the end of the flashing if it extends beyond the additional rafter.

At the junction between the upstand and the side flashing, the apron flashing should not be cut, as that will form a leak path. The flashing should be bossed, or a section welded in. Where the flashing is dressed onto the head of the tiles it is common for the flashing to form a trough between the framing and the tiles, which in some cases is up to 100mm higher above the rafter face. Water that is trapped in the trough can run sideways and under the first course of tiles on either side. At this point there should be a welt to stop the water flowing off the end onto the underlay. It is better to have no trough there in the first place.

Some units have the apron flashing built in, while others have to be installed separately. Regardless of which situation applies, the flashing should be long enough to lap over the lower course of tiles/slates. In many instances the flashing is just capable of achieving 150mm of lap onto a slate that is butted up to the unit framing, but is not long enough where the gauging-out results in a gap between the head of the tile/slate and the chimney/dormer window framing, or where high-profile Roman or Pantiles are used, as the flashing has to rise up to the height of the corrugation, reducing the lap length.
